Re-Connecting Canada, Perched Culvert Outlet Fix

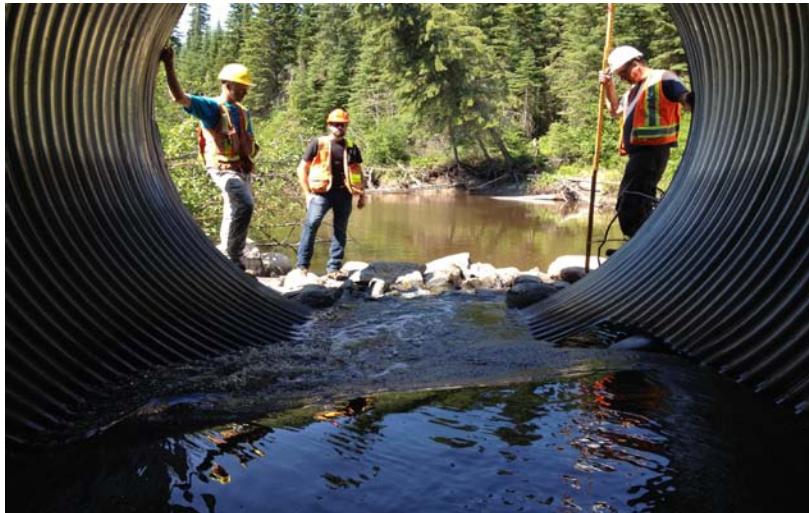
Not all culverts are installed properly. A perched culvert, on a stream tributary, will destroy connectivity making fish spawning impossible. Sadly there are thousands of these installations across Canada.

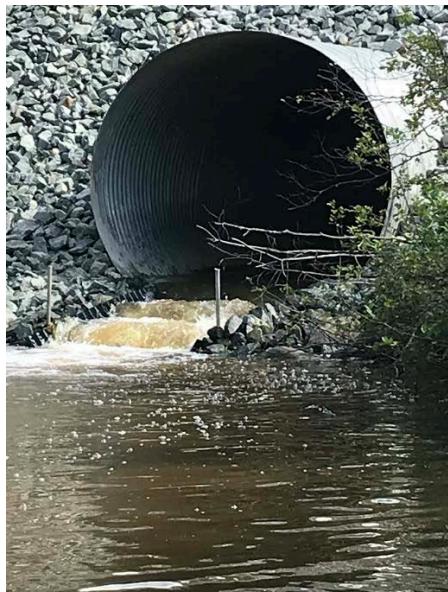
On this project a 3600mm diameter CSP was set on top of a rock outcropping. A hole was cut in the pipe to accommodate the rock. As a result there was a 400mm drop through 3.5 meters of rock rubble. The stream disappeared and fish passage in both directions was eliminated.
