Piercy Creek Arden Road Fish Ladder – Assessment and Review

Millard-Piercy Watershed Stewards
3430 Sandpiper Drive
Courtenay, BC, V9N 9T9

January 13th, 2025

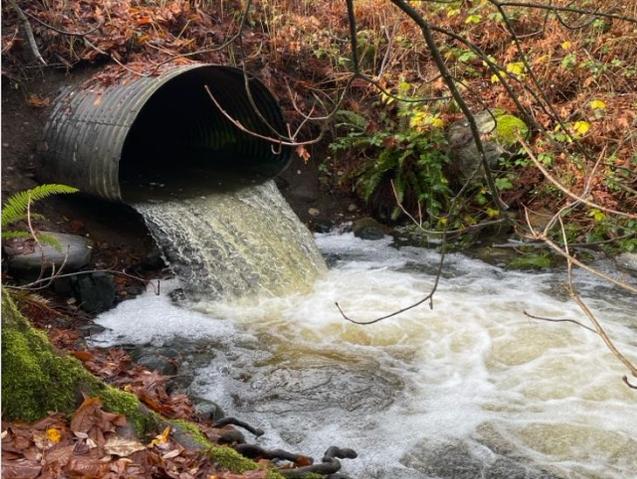
Image 2. Arden Road hanging culvert “before”

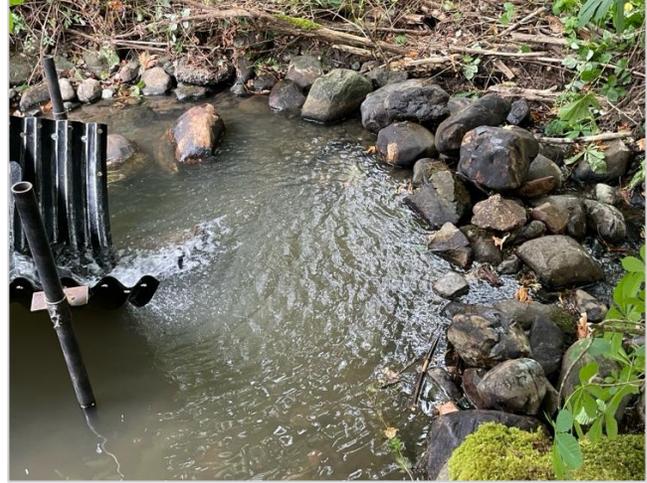
Image 3. Arden Road culvert outlet pool

sections of FishCulvert (Image 5). The FishCulvert was installed at a slope of approximately 35% (vs. the maximum recommended slope of 25%), due to the short length of the outlet pool below the culvert.

- Reducing the slope of the FishCulvert from approximately 35%, to below the maximum recommended slope of 25% by adding another section. In this installation, the short outlet pool and slope of downstream channel warrants further in-stream modification for the FishCulvert slope recommendations to be met. Further remediation or modification to the outlet pool would not only increase FishCulvert success, but would also increase connectivity (Fleenor & Silvester, 2018)³. Ideas for modifications to the outlet pool include extending the pool by removing surrounding boulders and installing a weir or second fish ladder if downstream slope is deemed a barrier to fish.

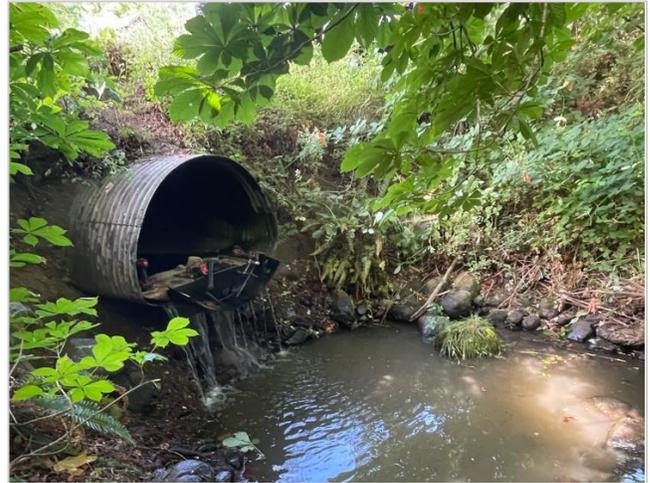
Image 5. FishCulvert mounting bracket; hanging culvert and outlet pool

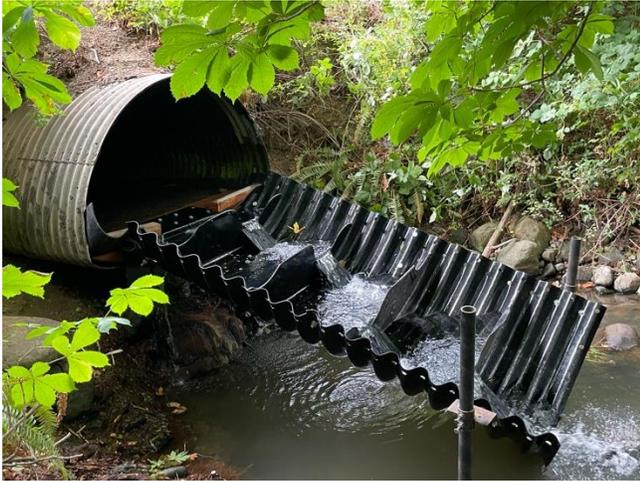
The FishCulvert was installed during August low flows, where typically, the hanging culvert would be a complete barrier to fish passage (Image 6). During the first significant rain events of the season (October 1st and October 18th), all of the flow through the culvert was from the Copperfield Ridge subdivision and Cumberland Road (Image 7&8) and flow was considered moderate. After a heavy rain on October 23, a significant volume of water from Piercy Creek began flowing from above Arden Road and through the culvert and FishCulvert (Image 9).

Image 6. FishCulvert at August low flows

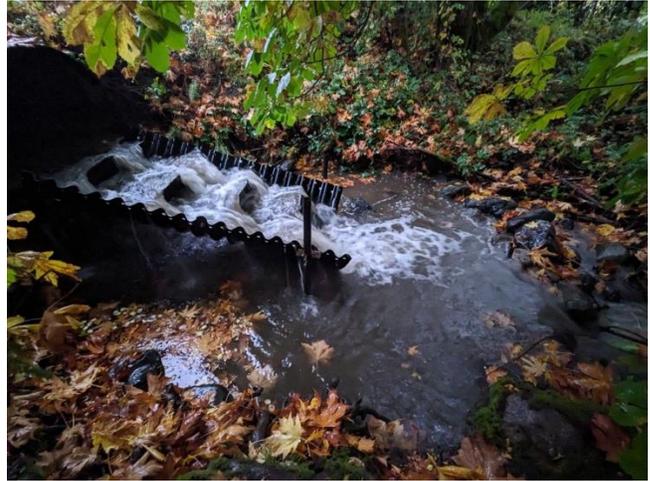
Initial observations indicated that at medium to high flows, water moving through the FishCulvert was very turbulent and appeared likely to impede fish passage. During these flow conditions, observers noted several fish attempting to enter the FishCulvert that instead landed on the structure's edge or in turbulent flows and were flushed back into the outlet pool (Image 10). Juvenile fish were unsuccessful at entering the FishCulvert during these flow conditions as turbulent flows washed them back into the outlet pool (Image 11).

Image 7. FishCulvert at early-October moderate flows

- Adding a cover to all vertical edges of the FishCulvert to reduce possible damage when jumping fish land on the sharp edges.
- Reducing baffle heights and changing configuration to reduce turbulence at high flows which coincide with peak fish movement.

- Increasing spacing between baffles to accommodate larger Coho and reduce turbulence.
- Adding a section of white plastic on top of the wood end dam to allow observation of fish swimming over the top of the FishCulvert into the road culvert.

- Widening the FishCulvert to reduce flow velocity out of the road culvert. Turbulence would be consequently lowered, which will allow fish to regain control when entering the FishCulvert.

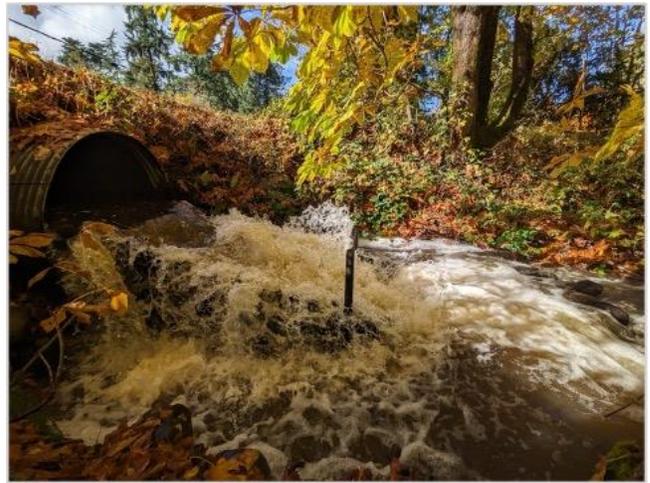
Image 9. FishCulvert at mid-October high flows

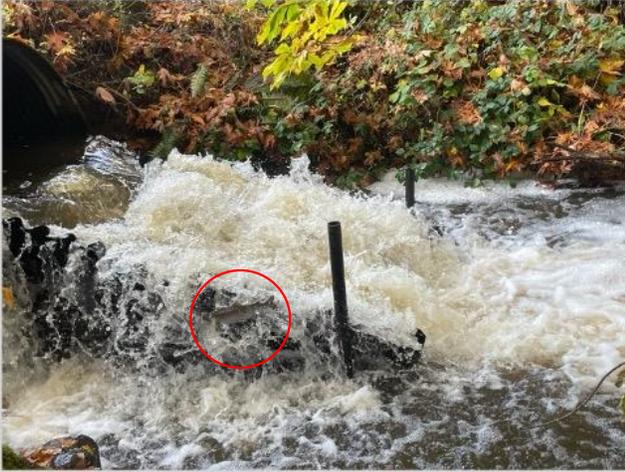
Image 10. Fish flushed back into outlet pool

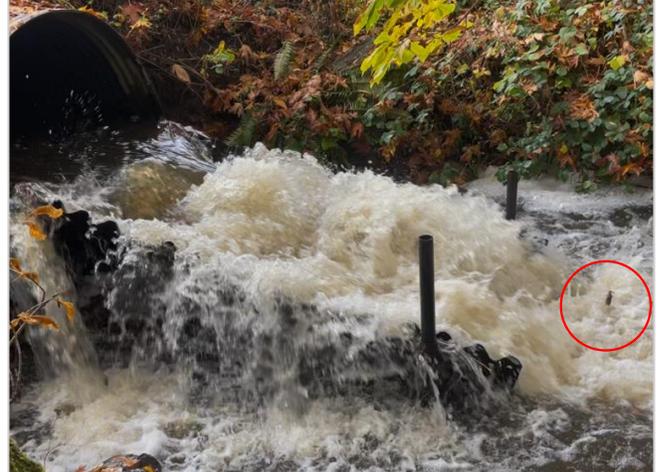
Image 11. Juvenile fish unable to enter FishCulvert
